## TECHNICAL NOTE

<b>Contract</b>	NAS8-32982	<b>Date</b>	30 June 1982	<b>Doc.</b>	LMSC-HREC TN D867570
-----------------	------------	-------------	--------------	-------------	----------------------

<b>Title</b>	RESULTS OF TESTS OF K5NA AND A REVISED FORMULATION OF EPDM/CORK PATCH MATERIAL IN MSFC HOT GAS FACILITY
--------------	---

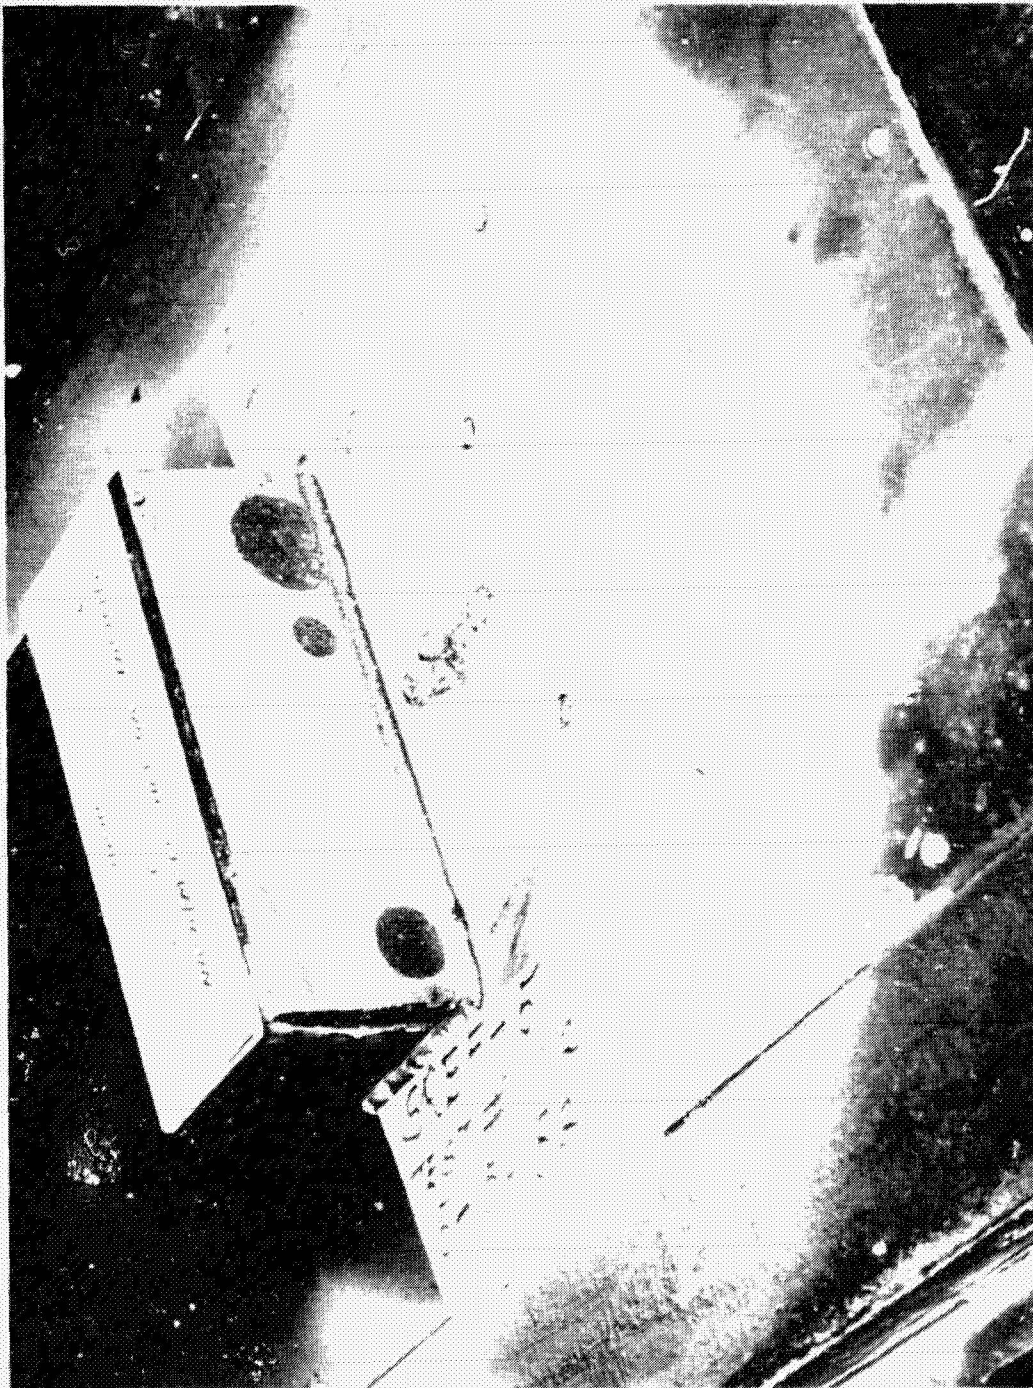
Fig. 3 - Post-Test Photo of Model SREF-5

Figures 2 through 7 show typical pretest and post-test photos of these four models.

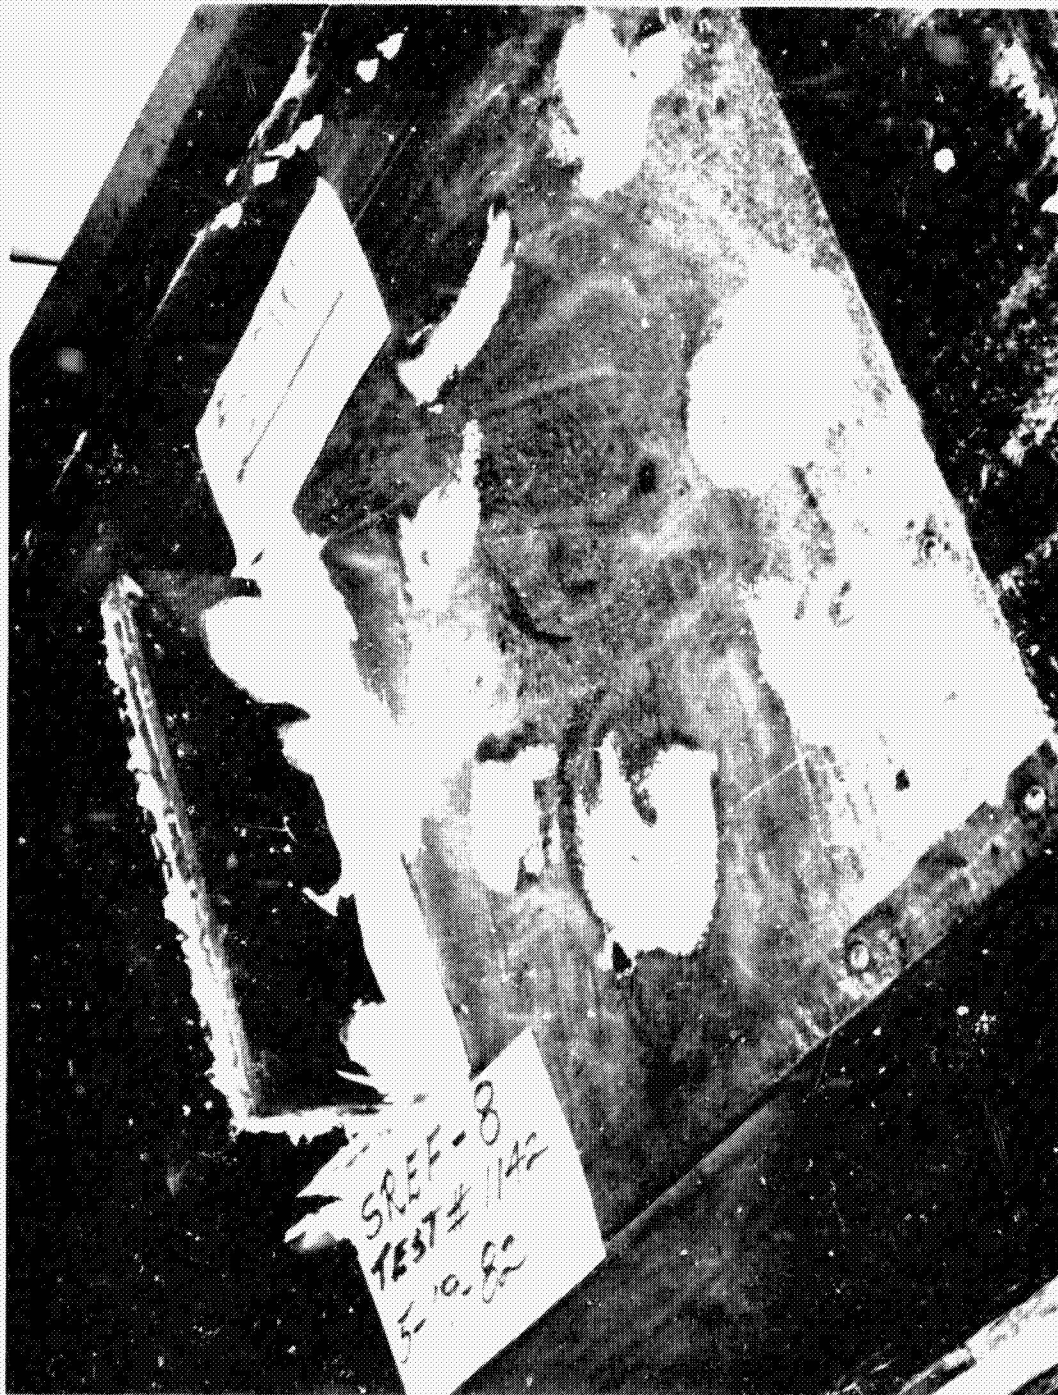
Fig. 6 - Pretreatment of Model SREF-8

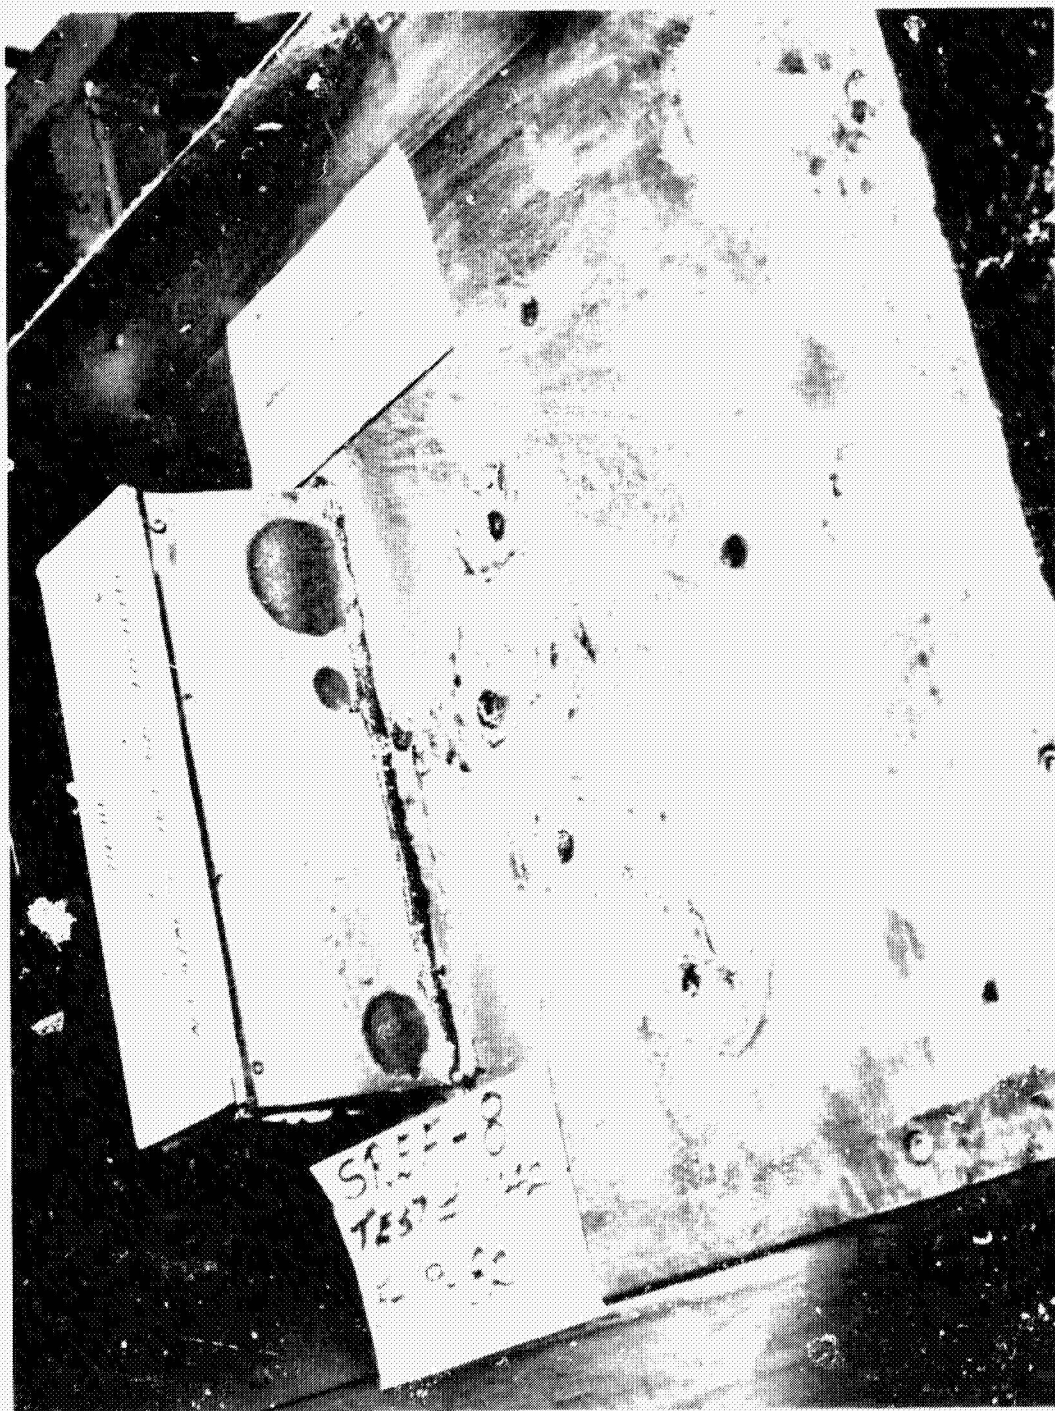
Fig. 7 - Post-Test Photo of Model SREF-8
